RETROFITTING OF BUILDING

INTRODUCTION OF RETROFITTING BUILDING

RETROFITTING OF BUILDING STRUCTURES DAMAGED DUE TO EARTHQUAKE

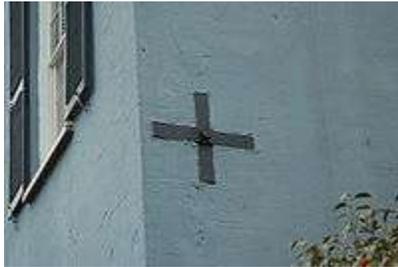
One of many "earthquake bolts" found throughout period houses in the city of Charleston subsequent to the Charleston earthquake of 1886. They could be tightened and loosened to support the house without having to otherwise demolish the house due to instability. The bolts were directly loosely connected to the supporting frame of the house.

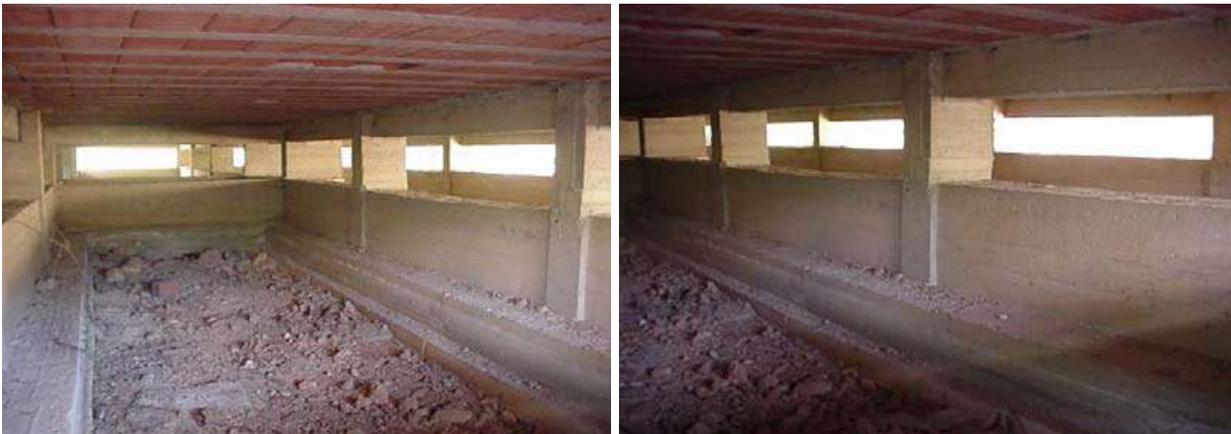
Fig. 16 Foundations of an IACP building in Solarino

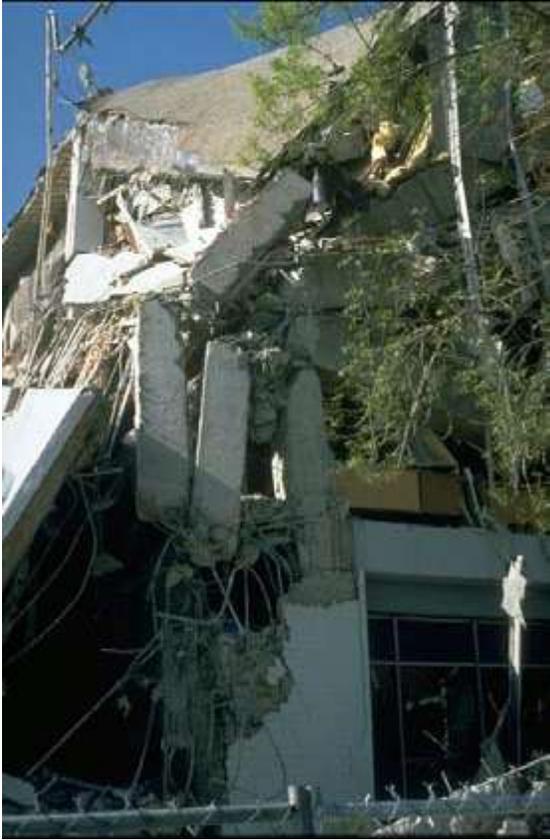
Joint failures – Northridge earthquake

Failures of beam-column connections also have been observed.

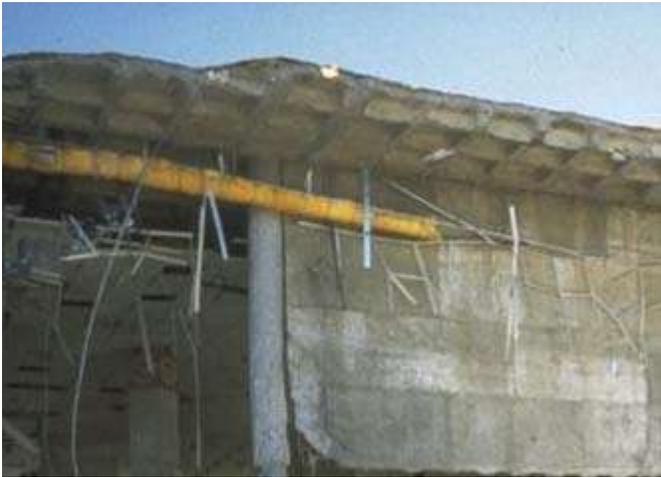
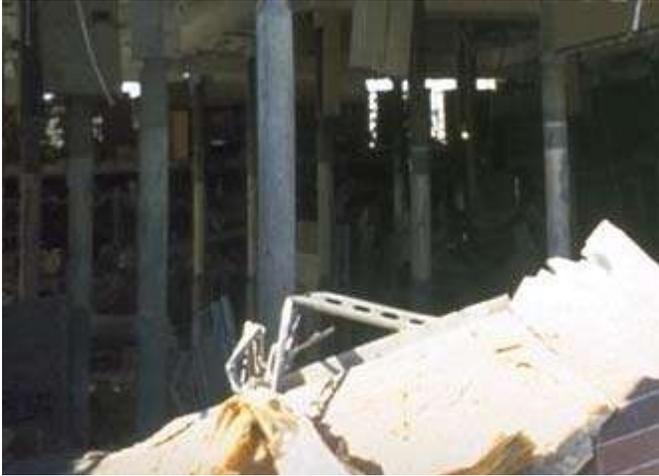
Slab-column connection failure – Northridge earthquake

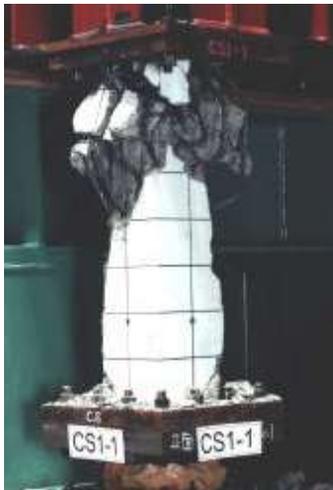
RC column (b) CRS-CL columns

On the other hand, the columns strengthened by CRS Method survived against three times of the same input motion. The bare reinforced concrete columns and CRS-CL columns after the shaking table test are shown in Photo 2.

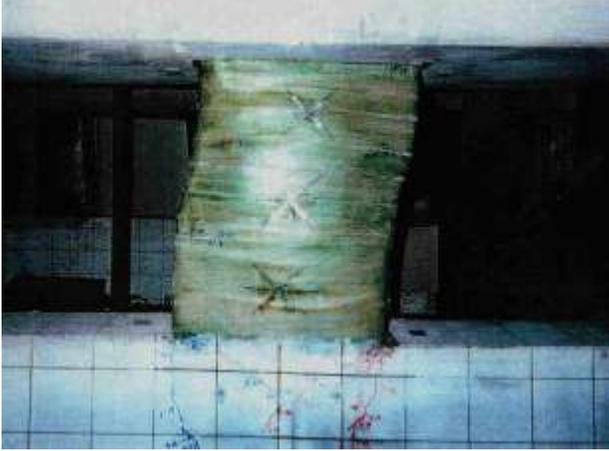
Short column with agamid fiber sheet

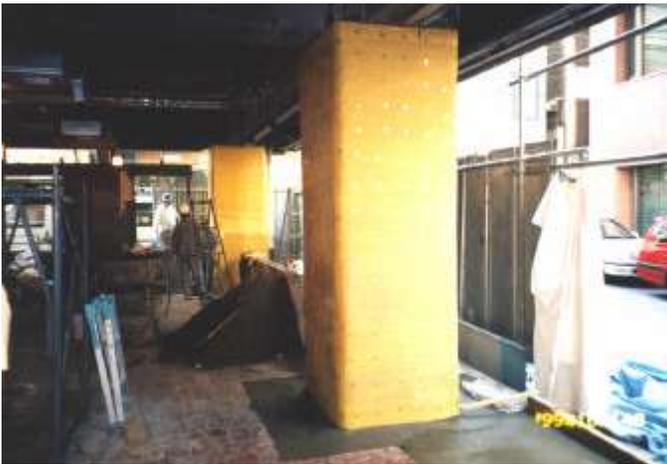
Shear strengthening of building columns

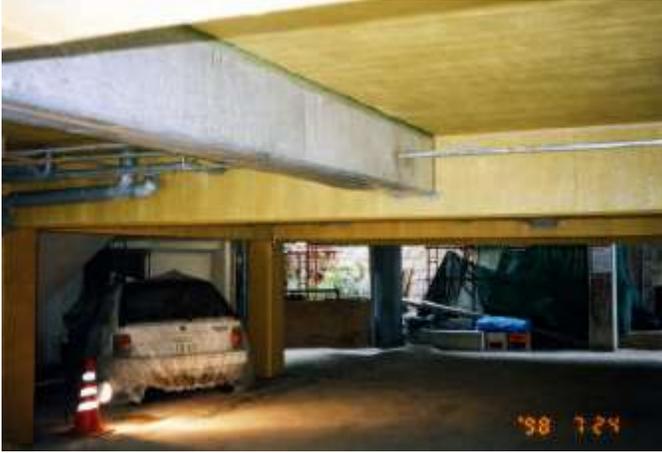
Strengthening and repair for girders and slabs

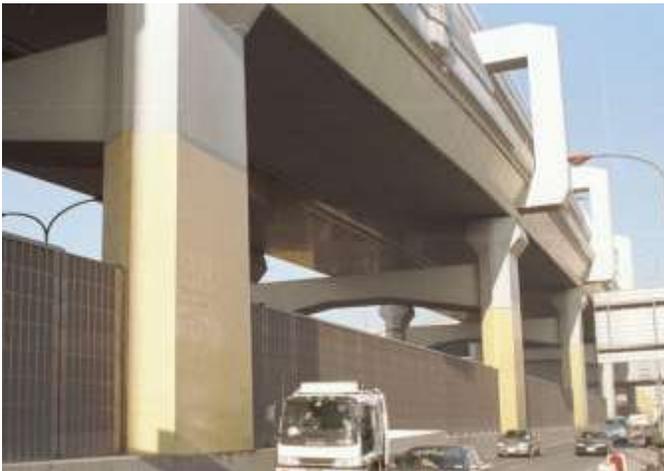
Strengthening for bridge piers

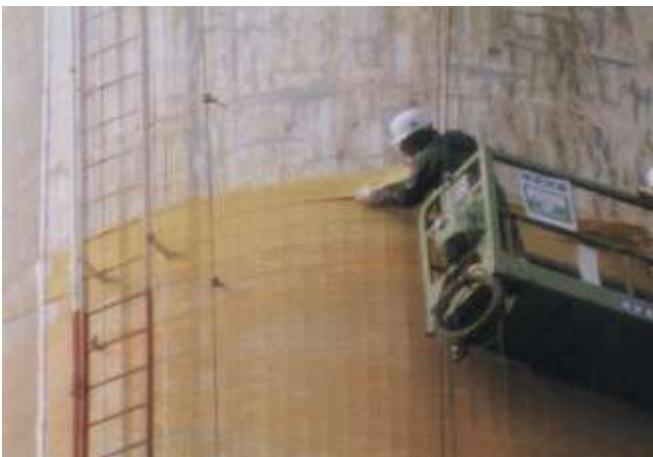
Repair for chimney

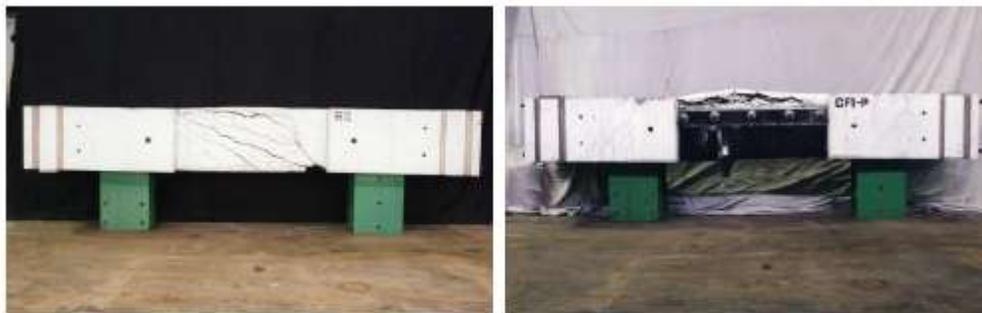
(a) unretrofit beam (b) retrofit beam
Photo 1 Specimens during and after tests

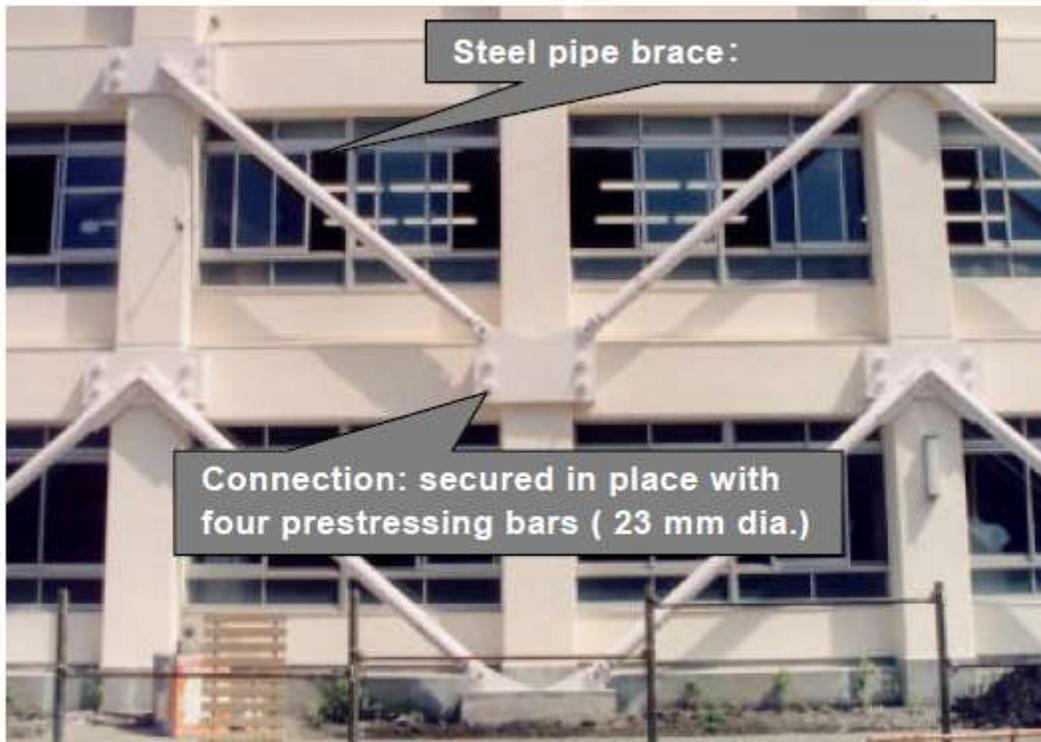
Installation method of external energy dissipation braces

Photo 2 shows an example of the external damping brace installation. External damping braces are installed on the existing structural frame (main structure) through anchorage bases. The space between the anchoring base and the side of the existing structural frame is filled with grout and the anchorage base is fastened to the main structure by using prestressing steel bars.

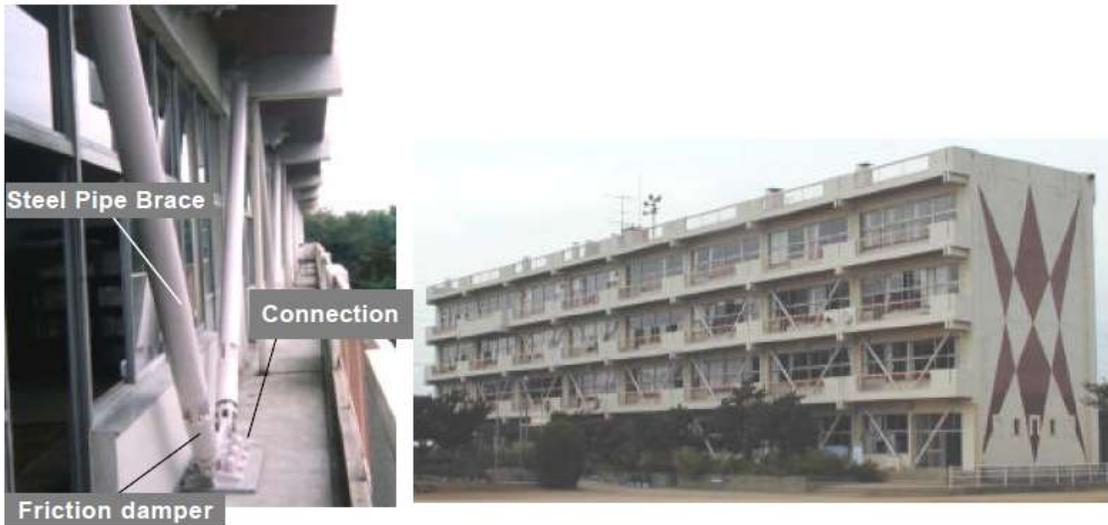
Photo. 4 Application to an balconied school building

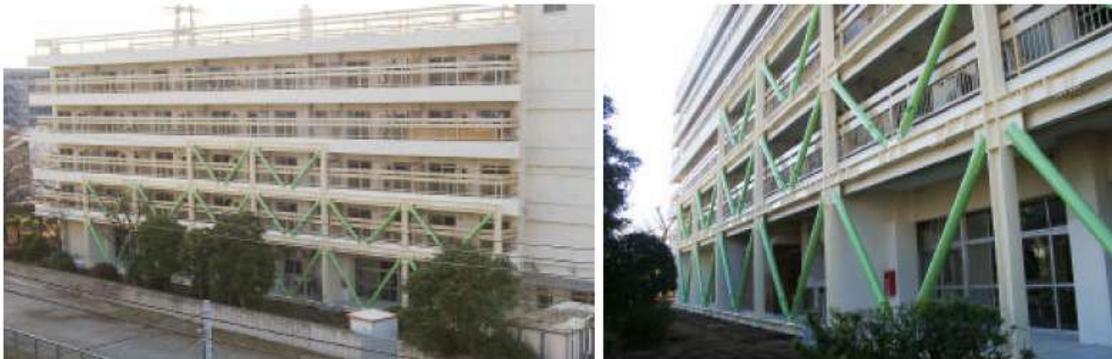
Photo. 5 Application to an apartment building

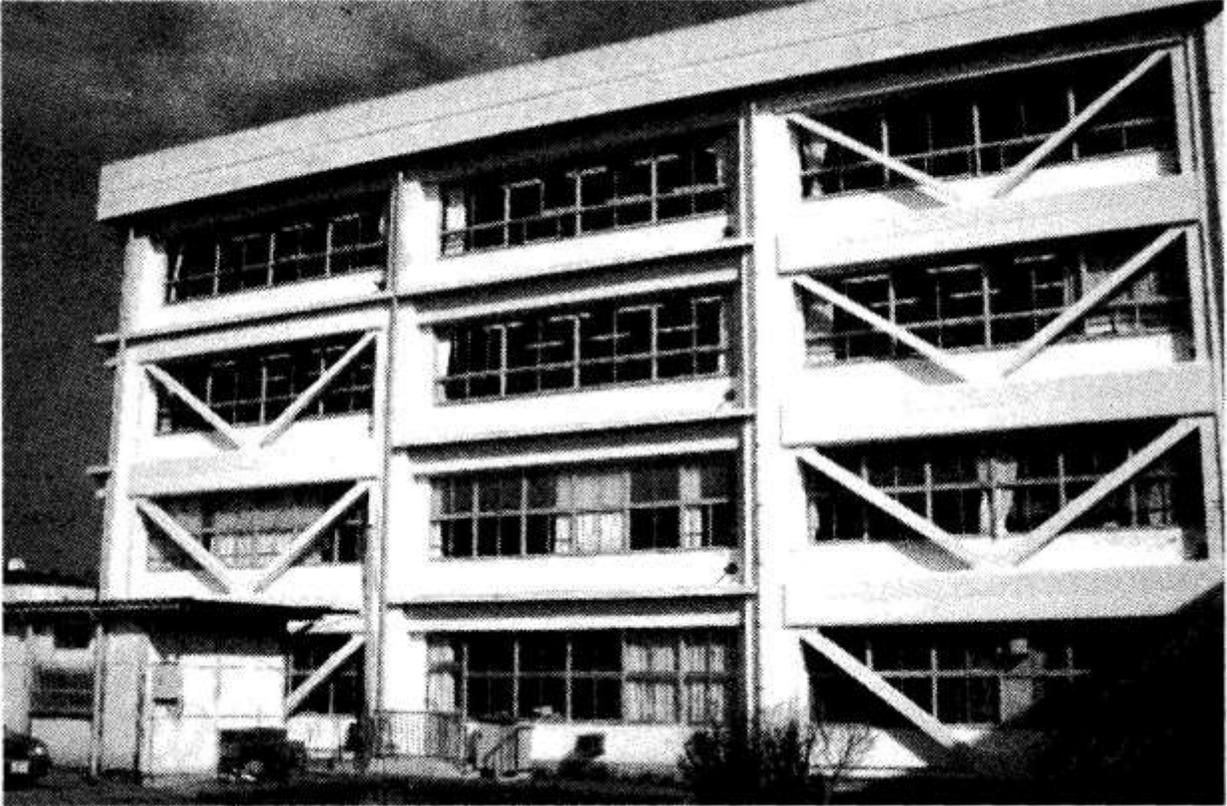
Retrofitted school building

The present seismic retrofitting method has been applied mainly to existing RC school and office buildings since 2001. Two examples of a four-story school and a three-story office buildings which were constructed in 1970 and 1967 respectively, are indicated by photographs 1 and 2. Damper devices are installed into the steel braces for seismic retrofitting in the latter building. The cost necessary for retrofitting by the present method is decreased about thirty percent in comparison with that of the conventional seismic method.
